THIRD STREET NORTHWEST TRAFFIC & SAFETY STUDY

GREAT FALLS, MONTANA

NOVEMBER, 1980

Robert Peccia & Associates

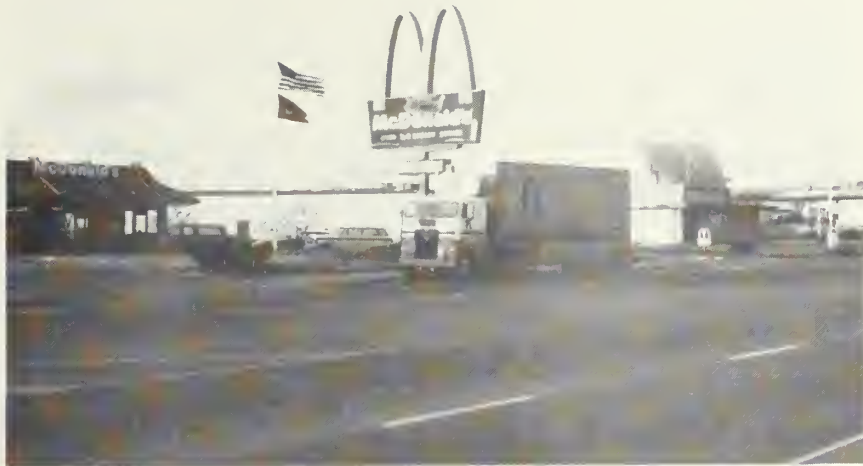
PHOTOGRAPH NO. 1

Example of sight distance limitations caused by on-street parking at Third and Seventeenth.

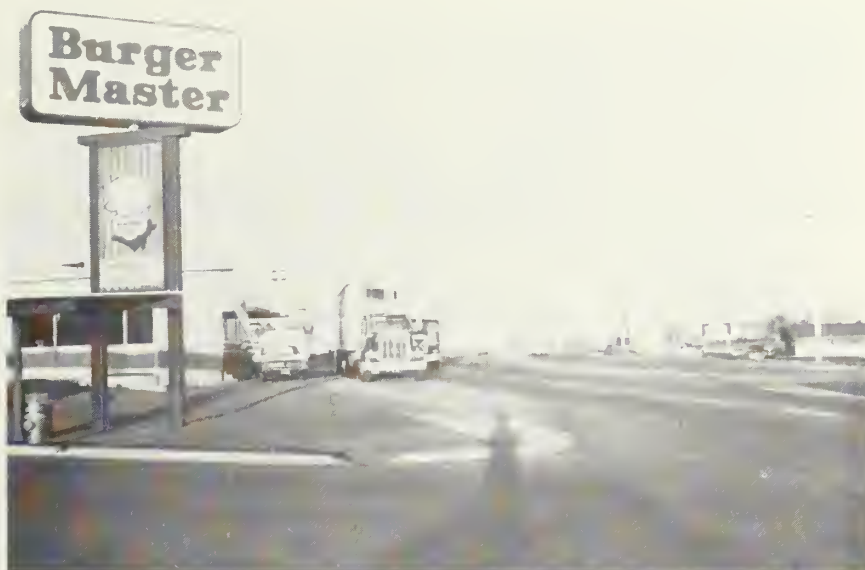
PHOTOGRAPH NO. 2

Burger Master driveway access to be signed exit only. Note sight distance limitations caused by on-street parking.

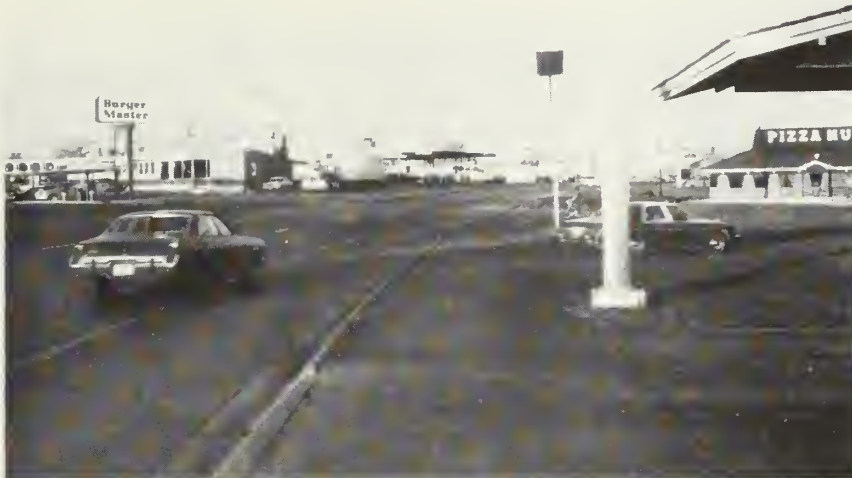
PHOTOGRAPH NO. 3

Vehicles entering Westgate Shopping Center through Exxon Service Station.

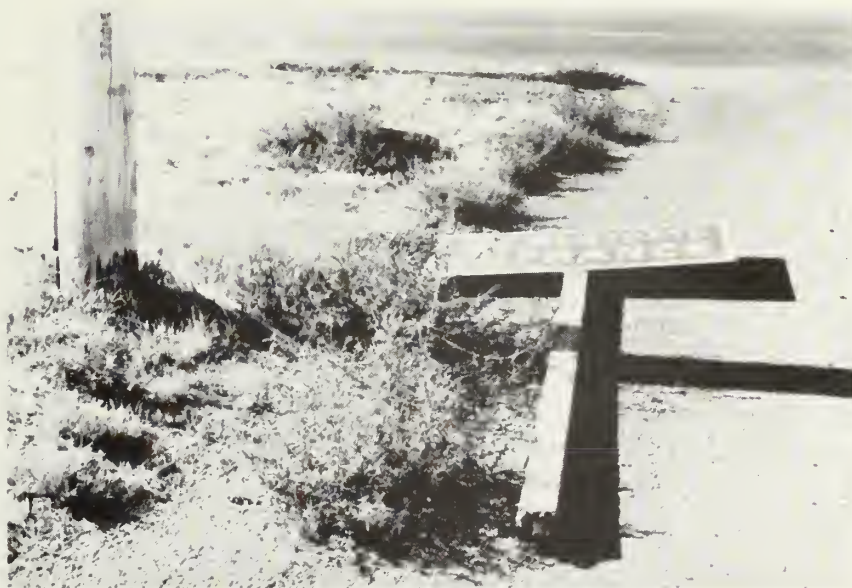
PHOTOGRAPH NO. 4

Confusion and delays are caused by the lack of proper entrance identification at Westgate Shopping Center.

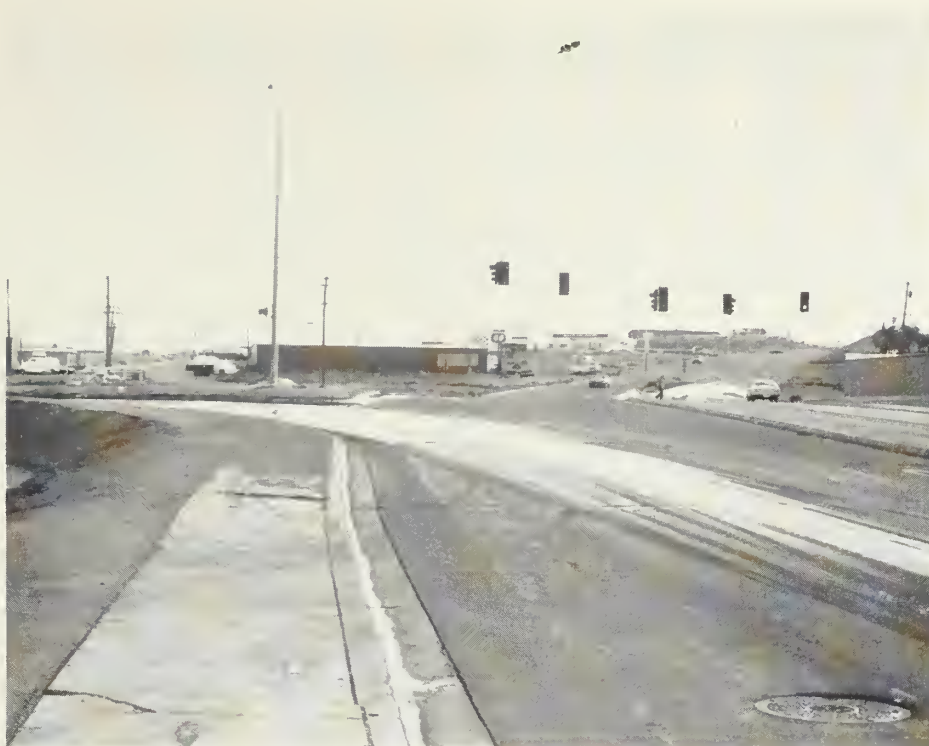
PHOTOGRAPH NO. 5

Wet pavement caused by median irrigation at Tenth and Smelter.

The raised medians in the vicinity of the Tenth and Smelter intersection were landscaped in the summer of 1980. The summer irrigation of the landscaped areas is automated on timers that water from 7:00 a.m. to 8:00 a.m. During observation of this intersection, it became evident that a traffic hazard was being created due to the watering of the grass and shrubbery on the medians. Excess water seeps from under the medians onto the roadway, and as a result the pavement is often wet until mid-afternoon (see Photograph No. 5). During the traffic conflicts study performed at this location, many conflicts were directly attributed to this wet pavement (i.e., erratic lane changes to avoid wet spots, skidding on wet pavement, dramatic speed changes approaching wet areas). It is also noted that a more rapid deterioration of the pavement will occur due to moisture contamination

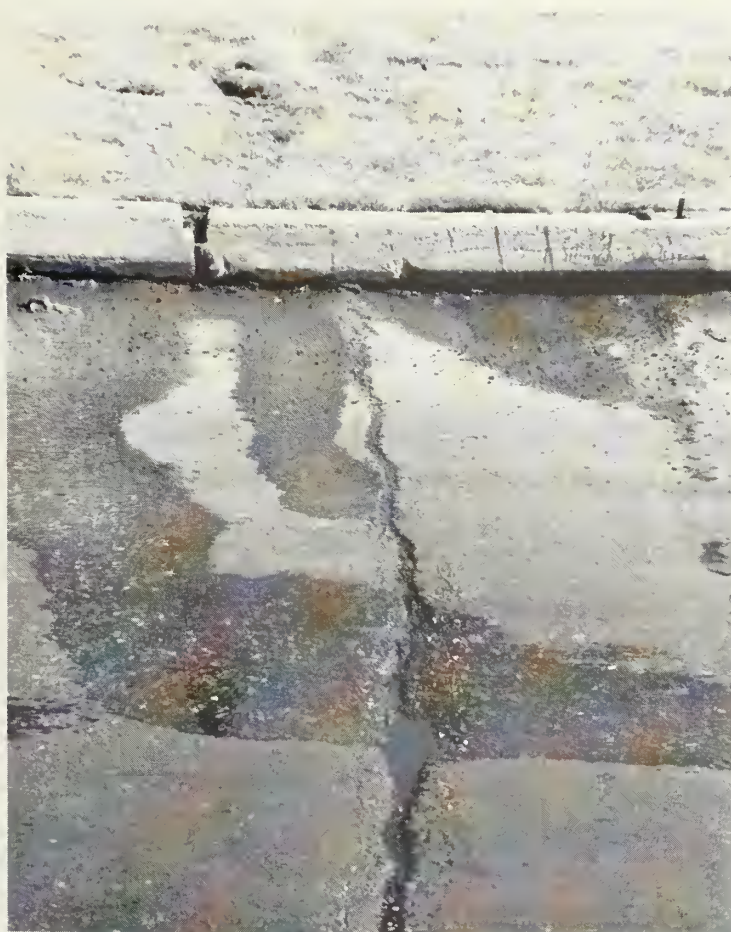
PHOTOGRAPH NO. 6

Increased deterioration of roadway surface caused by moisture seepage under median at Tenth and Smelter.
